# **Pentium® II Xeon™ Processor Specification Update**

Release Date: November 1998

Order Number: 243776-007

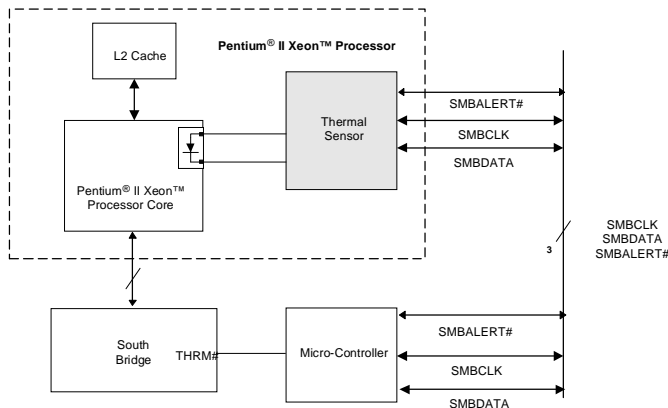
**Figure 1. An Example of Micro-controller Driven Thermal Management**

### D30. Thermal Sensor May Assert SMBALERT# Incorrectly

**PROBLEM:** The Pentium II Xeon processor has a thermal sensor that monitors the processor core's temperature. The thermal sensor asserts SMBALERT# if the processor temperature exceeds the temperature limits set in the Alarm Threshold Registers ( $T_{HIGH}$ ,  $T_{LOW}$ ). It also sets the corresponding Status Register bits to identify the cause of the interrupt. Figure 1 gives one example of the how the SMBALERT# signal could be used in a system.

Under the conditions described below, the thermal sensor incorrectly generates the SMBALERT# interrupt. *All* of the following conditions must be met to trigger a false interrupt:
